**A clinical evaluation of all-ceramic bridges
placed in UK general dental practices: three-year results**

Purpose: To report the results at year three of an evaluation of the performance of fixed-fixed all-ceramic bridges, constructed with a yttrium tetragonal zirconia polycrystal substructure, placed in adult patients in UK general dental practices and cemented using a self-adhesive resin-based cement

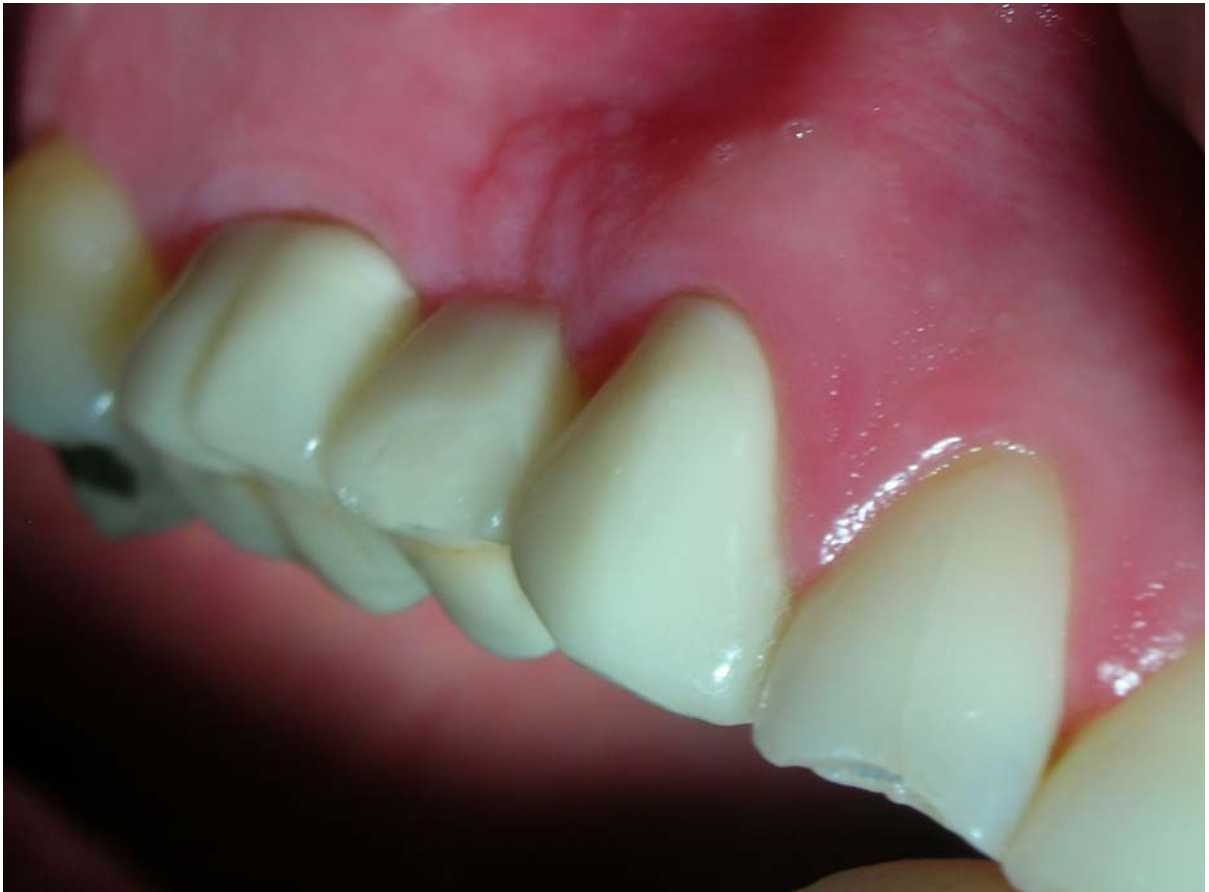
Fig 1

All (100%) of the bridges examined were present and 94% (n=32) of the bridges were intact. In addition to the small chip which was detected in the veneering porcelain on the palatal surface of a upper premolar retainer reported in the year-one paper¹, a further larger chip on the buccal surface of an upper premolar pontic was detected at two-years¹¹. This chip extended to the veneering porcelain/zirconia framework interface and though the patient was quite happy with the aesthetic appearance it was decided, in conjunction

with the chief investigator and the manufacturer, to recommend repair using a micro-blasting device and composite. On review at year-three the repair had been lost and the patient was offered a replacement bridge at no cost. The patient declined as he stated he was quite happy with the polished buccal surface of the pontic (Fig 1).

Figure 1: Chipping buccal surface of UR4 pontic (3 unit bridge).

Though all the bridges examined at the third-year review were present and intact mention has been made of previously detected chipping of the veneering porcelain in two cases. The first case, reported at year-one¹, was a small chip approximately 1mm in diameter, wholly within the veneering porcelain and unnoticed by the patient. This was smoothed and re-polished and the bridge has continued to perform satisfactorily. The second larger chip reported at year-two was on the buccal surface of an upper premolar pontic was approximately 5mm in diameter, with the veneering porcelain/zirconia framework just exposed at the deepest central part. Repair of the defect was attempted using a micro-blasting device (CoJet Intraoral Repair System, 3M ESPE, Seefeld, Germany)^{18,19}. This system uses silica-coated alumina particles delivered under pressure (nozzle pressure of 5 bars for 10s at 10mm distance) to form a micro-roughened silicatised layer on both the chipped veneering porcelain and the exposed Y-TZP material. Without this silicatised layer on the non-silica based Y-TZP there would be no chemical adhesion to the applied silane (3-methacryloxypropyltrimethoxy silane). It has been demonstrated that this system significantly improves the bond strength of resin-based materials to zirconium-based ceramics²⁰. However, as reported, on this occasion the repair failed and though offered a replacement bridge the patient was very satisfied both with functionality and appearance of the

smoothed and polished fractured surface (Fig 1). The acceptability of the shade-matched exposed zirconia framework suggests the possibility of using this material just with a surface glaze, with anecdotal information having been received that some practitioners are using this rather than a full ceramic veneer (perhaps in posterior regions until a translucent zirconia is available) though it has been shown that the overlaid ceramic veneer does contribute to the overall strength of the restoration^{21,22}.

In the current study the two chips described earlier would thus be classified as one Grade A and one Grade C. The overall rate of chipped restorations in the current study is 6% at three-years which compares well with rate reported in similar studies of between 3% and 25% over a similar time period^{7,23,28}.

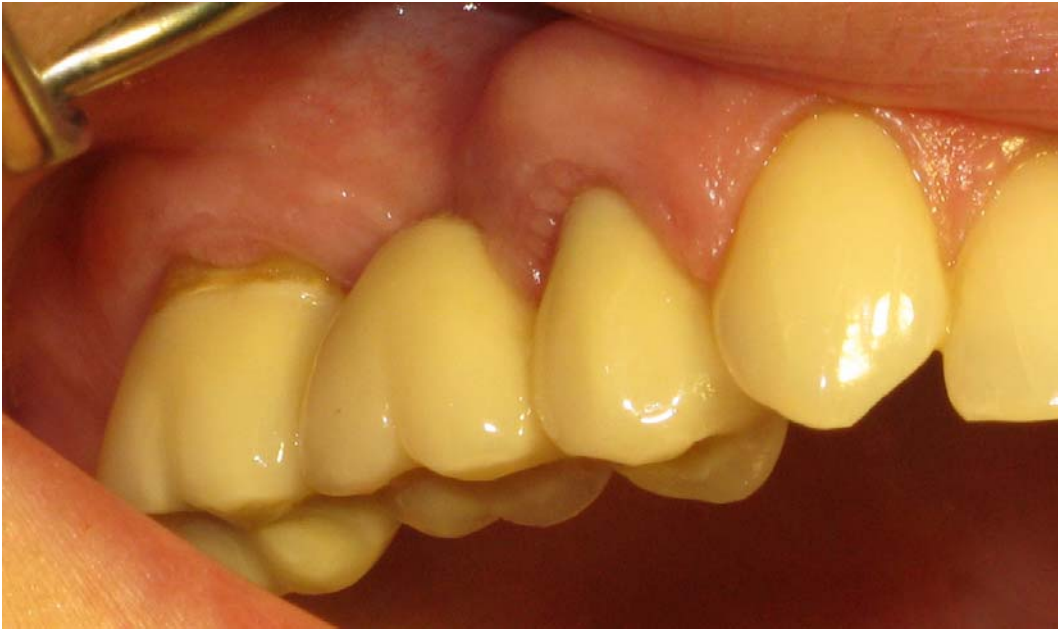
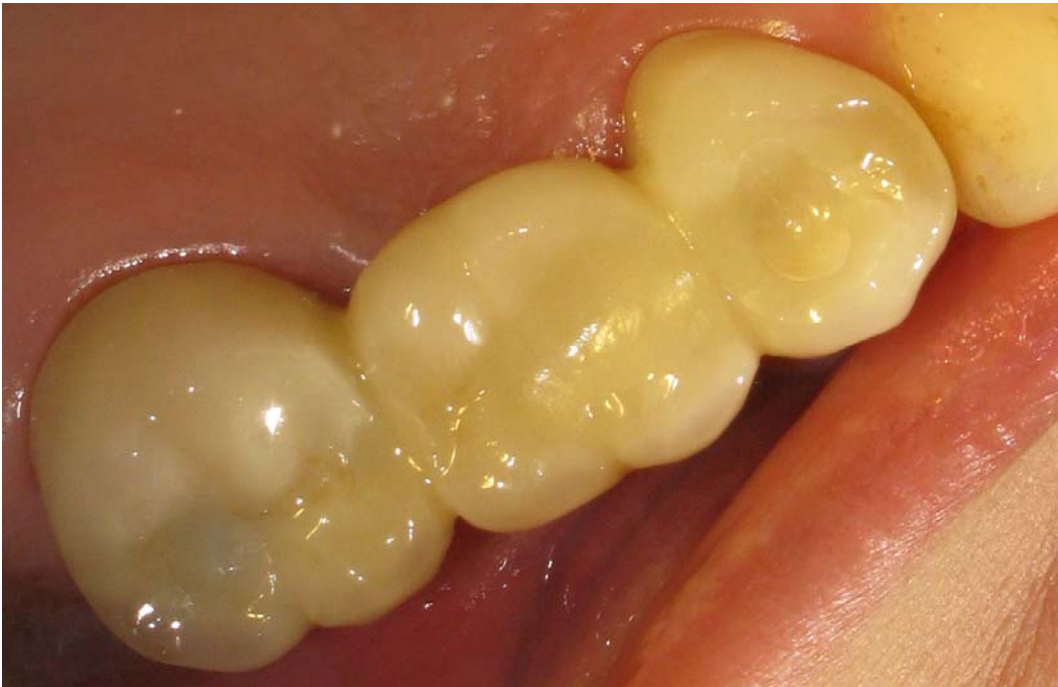
Fig. 2

It was noted at the three-year assessments that an access cavity for successful endodontic treatment had been prepared & restored in the occlusal surface of a pre-molar retainer (Fig 2). The endodontic treatment of

Figure 2: Two views of the endodontically treated UR5 abutment (3-unit bridge).

By year-three, a total of two molar and one premolar abutments (4% of the total at baseline) had been endodontically treated successfully after investigation of symptoms. Access cavities had been prepared in the occlusal surface of the retainers, and the final composite restorations were optimal when examined using the same Ryge criteria (Fig 2). The Lava bridges involved were otherwise intact and continued to perform well. 91% (n=31) of the Lava bridges were scored as optimal for marginal adaptation with no unacceptable scores recorded and no secondary caries was detected.

two heavily-filled molar abutments was reported at in the first-year paper¹ and these two bridges continue to perform well. A total of 3 (4% of the 68 abutments examined at 3 years) of the abutments in this trial have now been endodontically treated with the bridges were otherwise intact and performing well. This is similar to other reported rates of endodontic intervention in studies of all-ceramic zirconia fixed-fixed bridges over a similar time period^{23,29}. The final composite restorations placed in the access cavities were optimal when examined using the same Ryge criteria as the Lava bridges.

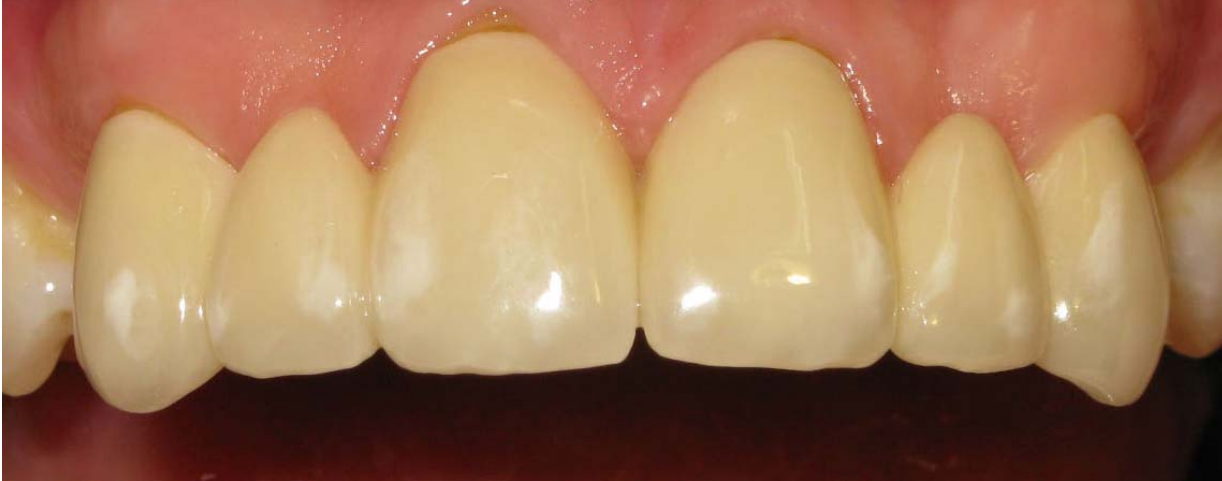
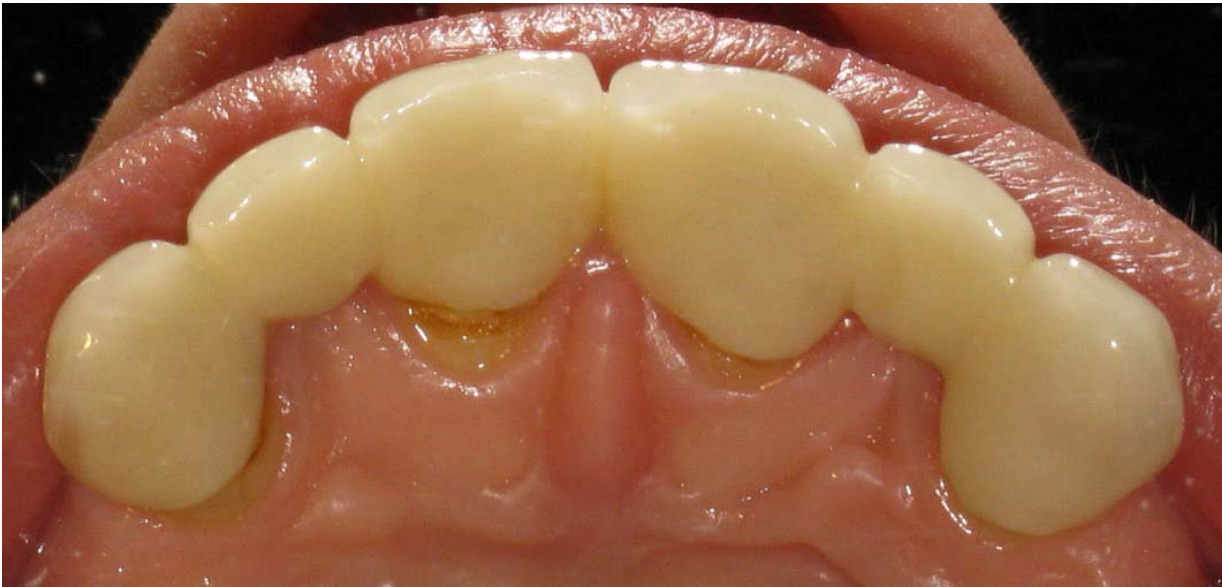
Fig.3

Figure 3: Two anterior 3-unit bridges at three-years (pontics UR2 and UL2)

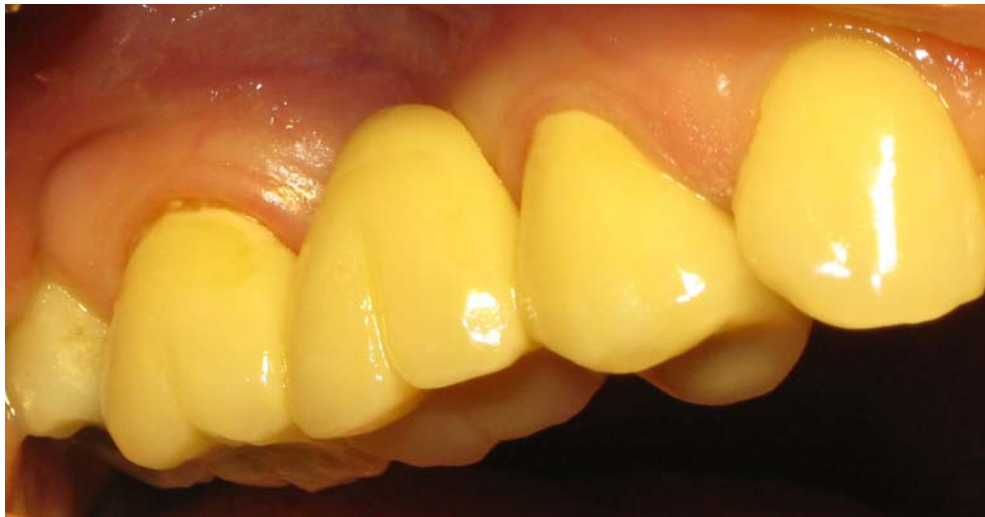
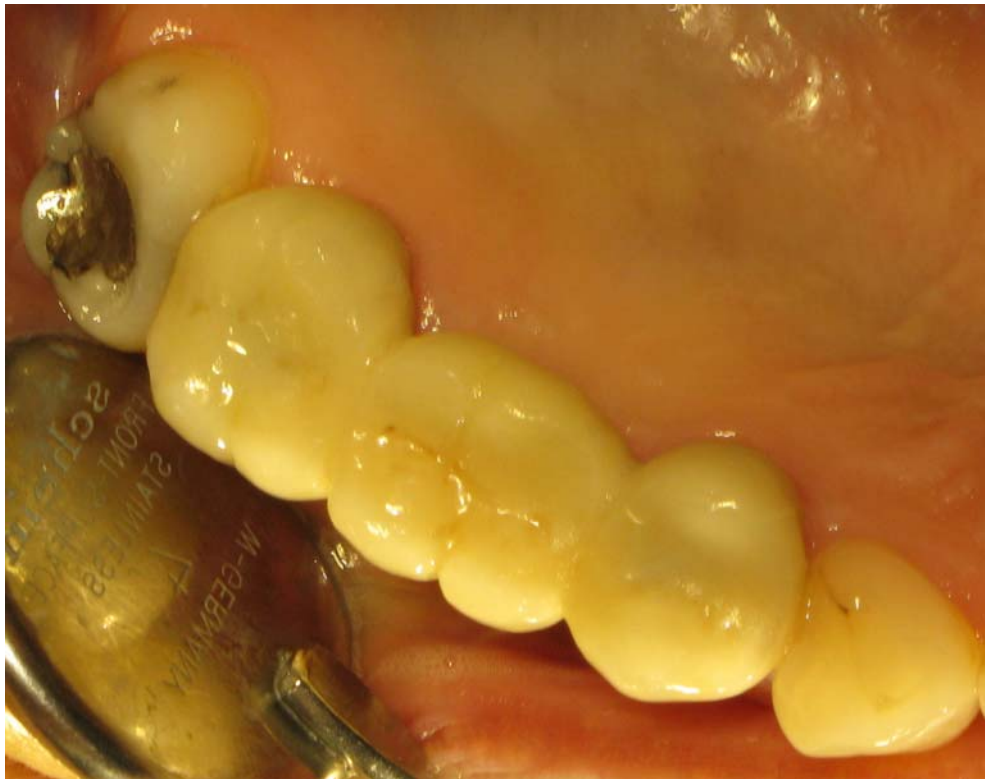
Fig. 4

Figure 4; A molar 3-unit bridge at three-years (pontic UR6)
